# TSM-DS Manufactured with Various Prepregs

T.F. McCarthy (Taconic)

## Preparation of Printed Circuit Boards

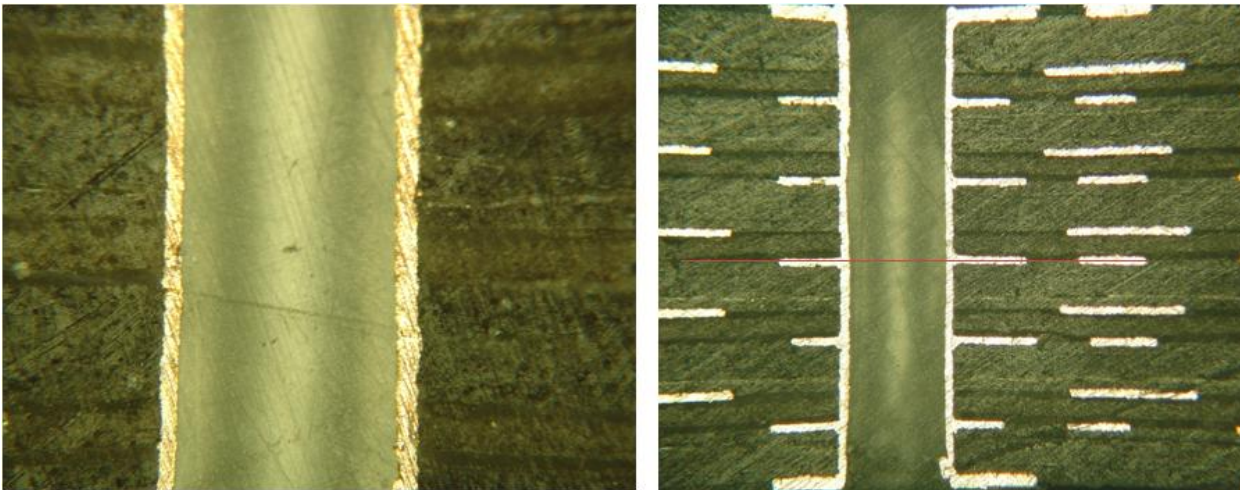
In general the plated through holes for these pwbs looked good. Defects were generally only at the entry material which suggested that the entry material was not optimal.

One key point to notice in the TSM/FR27 combination is that the pads are perpendicular to the barrel. This suggests that the prepreg layer is fairly stiff such that the drill cuts through the prepreg with some resistance such that the pad does not deflect. The TSM-DS/fastRise27 combination did have the occasional plating nodule that seemed to mostly be associated with the entry side of the pwb.

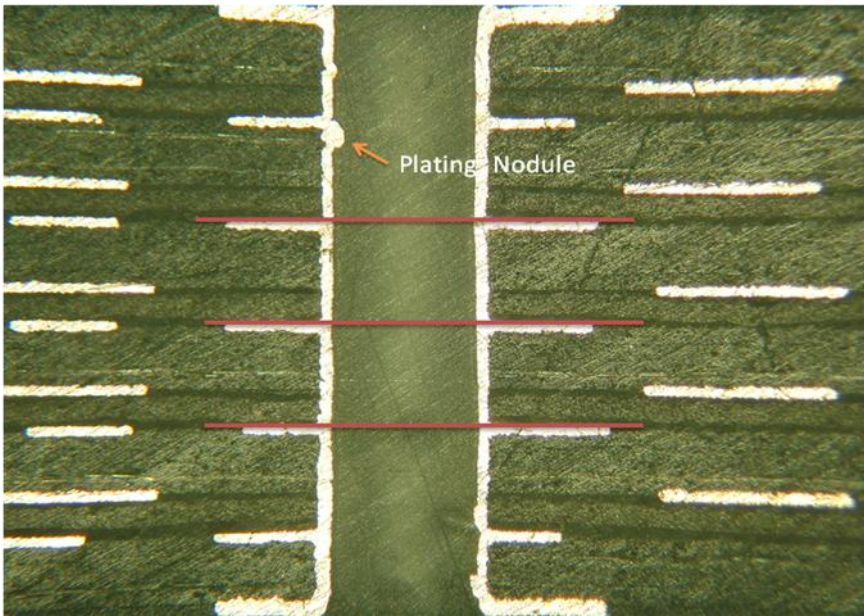
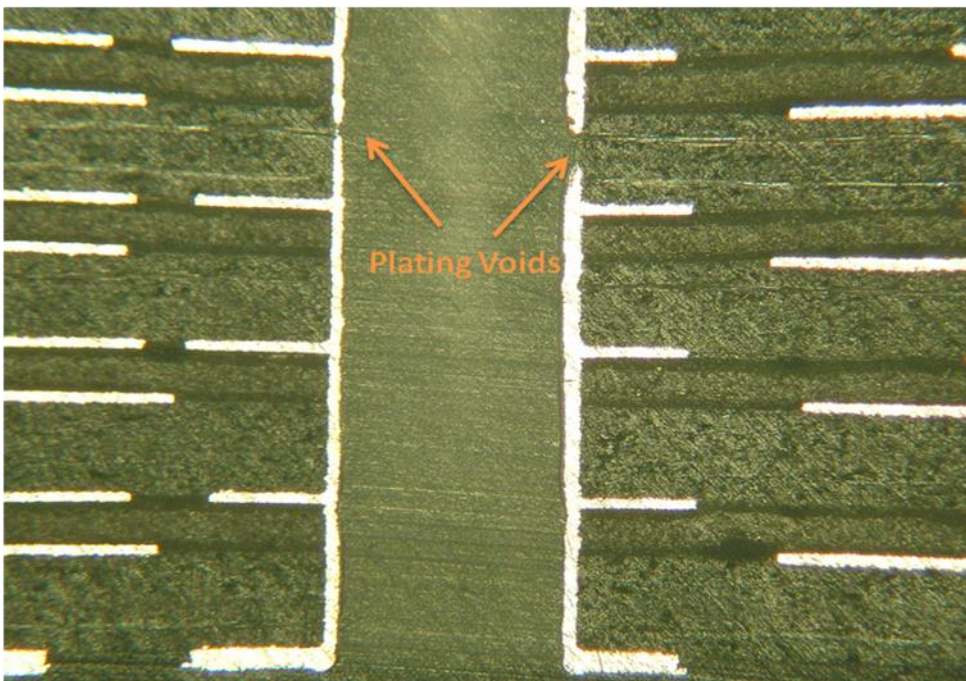
In general the plating of the fastRise27/TSM-DS pwbs was good. A few sections were found where the plating chemistry failed to plate the center of the drilled hole. The fact that the plating voids were only found on the TSM-DS areas suggests that the fastRise27 prepreg is relatively easier to plate than the TSM-DS.

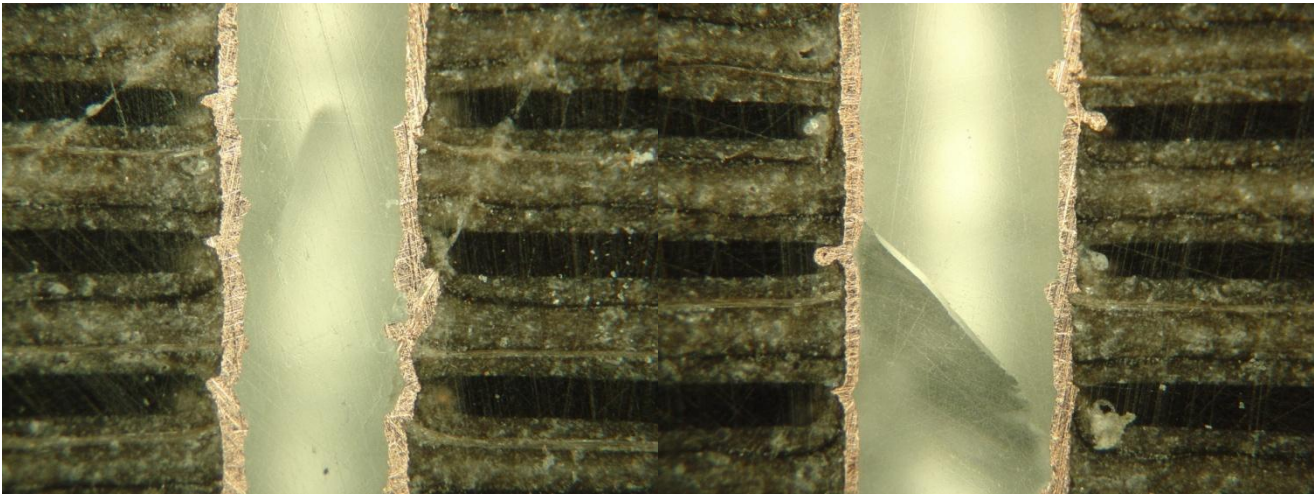
The TSM-DS/HT1.5 thermoplastic bond film demonstrated very rough holes. The film itself looked like small sections were torn at the edges leading to infiltration of plating chemistry.

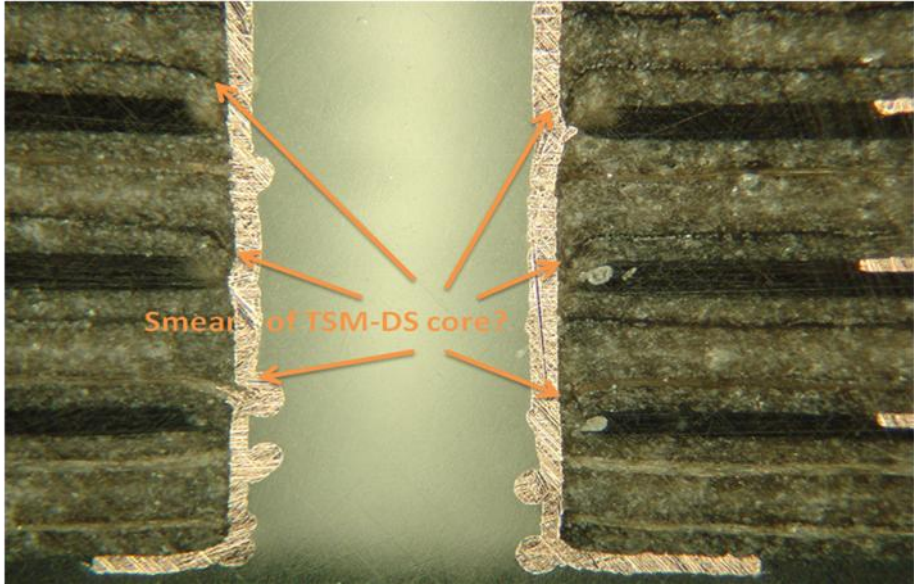
This migration of plating along the film lines might also be a result of the thermoplastic film melting during drilling causing some of it to deposit on the drill bit leaving behind a voided area where plating chemistry could enter. Some areas in the crosssections look like the core material has actually smeared across the thermoplastic film.

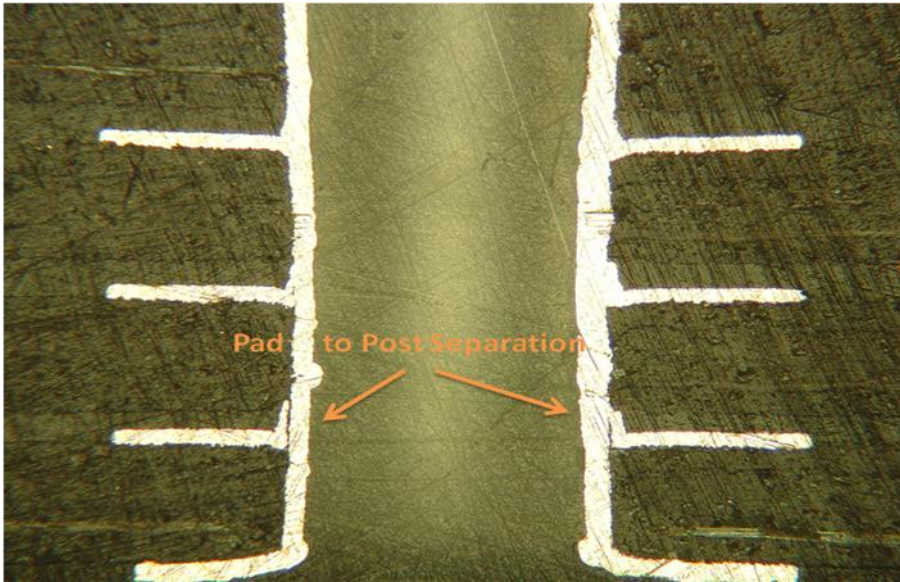
The smear of the TSM-DS core is probably related to the fact that the thermoplastic film melts and the TSM-DS core deflects. A more serious issue is the pad to post interconnect. Opens could be readily observed on the TSM-DS/HT1.5 bonding film interconnects.

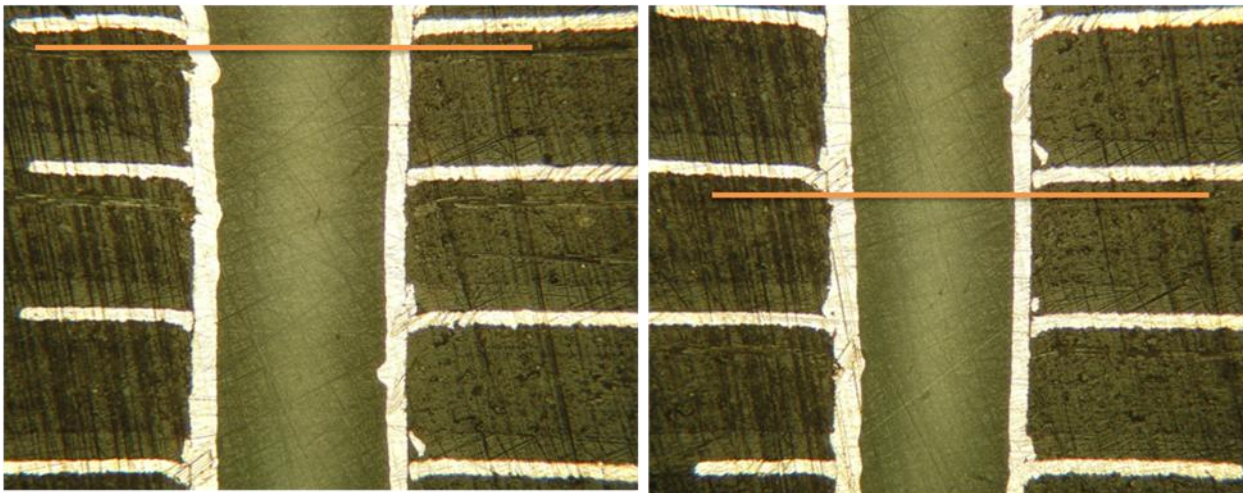
One could make the argument that the drilling parameters could be optimized for a given prepreg. However, the four stackups with TSM-DS/prepg contain 70-80% TSM-DS. The prepreg is actually a minority in these stackups. With the TSM-DS being constant in all stackups, the thermoplastic bond ply HT1.5 (Arlon 6700/RO3001) clearly had the highest probability of leading to opens as it appears that the thermoplastic melts during drilling. There also seems to be a deflection of the pad that leaves behind a leg that doesn't always plate to the barrel of the hole.

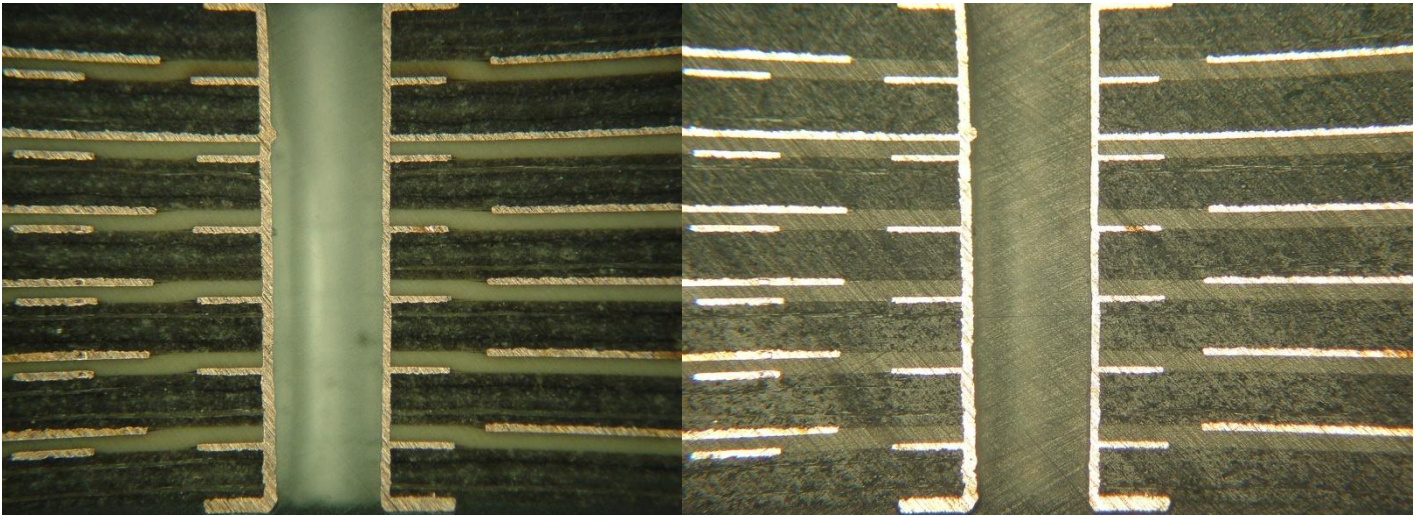
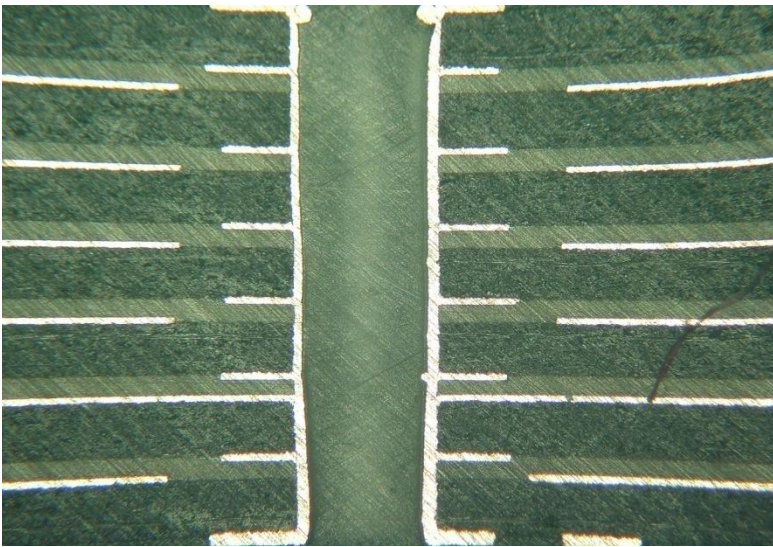
In general The TSM-DS/Speedboard C pwbs had good hole wall quality. There was the occasional plating nodule but the nodules were infrequent in nature. The plated through holes with lots of pads looked the cleanest.

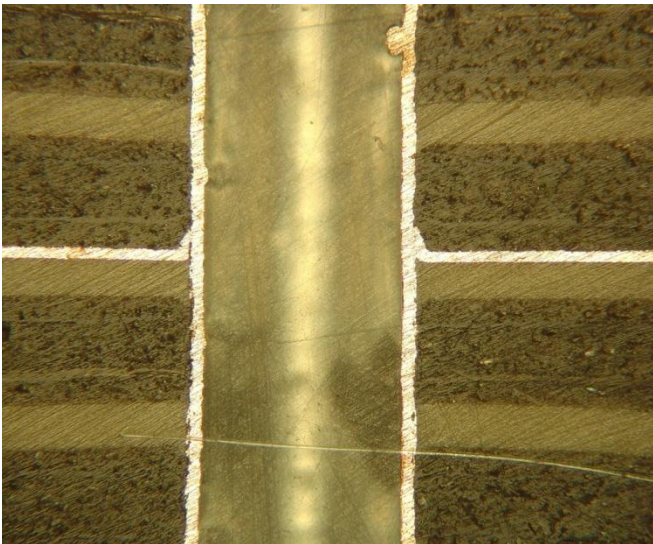
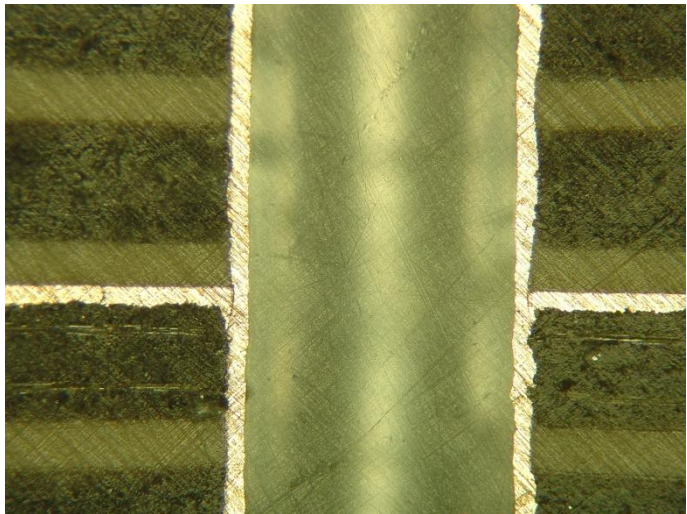
The TSM-DS/Speedboard C only showed what might be more serious defects in holes with one or two pads or ground planes. The plated through holes with heavy populations of pads probably has the effect of scrubbing the drill bits. As shown below, plated through holes with less copper planes showed in some cases what looks to be post to pad separation.

One cannot rule out however that the proper optimization of drilling conditions might be able to eliminate this apparent defect that only seems to appear in the areas having a low density of pads. One further defect that was noted in the TSM-DS/SpeedboardC stackup was the presence of voided areas. While the voided areas can probably be remedied by optimized plasma conditions, the locations of voids does suggest which materials are more prone to voids.

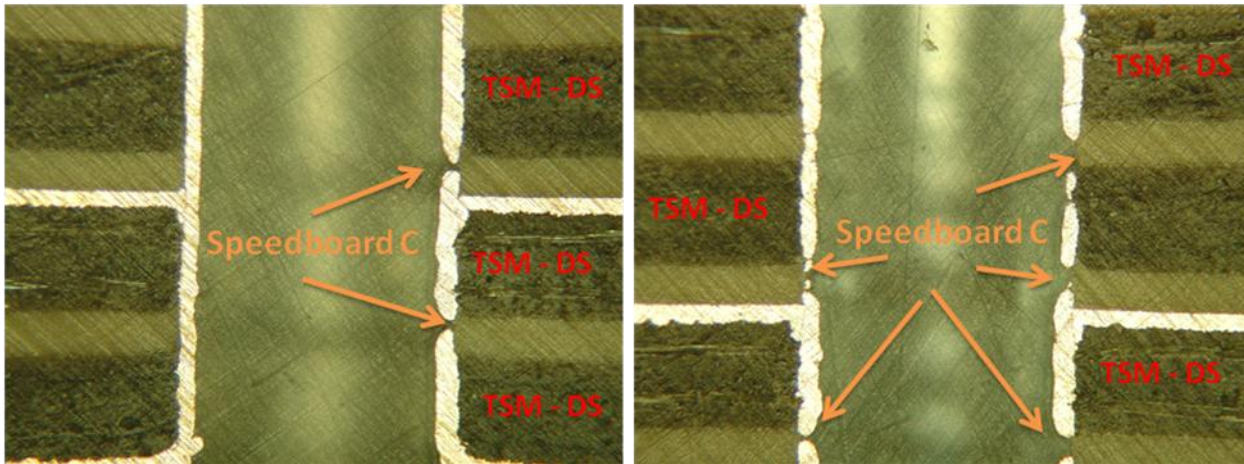
Voided areas were almost exclusively found on the Speedboard C areas. This only suggests that the TSM-Ds is easier to plate than the Speedboard C. Proper plasma conditions should be capable of generating reproducible and good quality plating through all the plated through holes. It should be noted that in the rare case of voiding on the TSM/fastRise27 stackup, the occasional void was on the TSM-DS.....suggesting that both TSM-DS and fastRise27 are easier to plate than SpeedboardC.

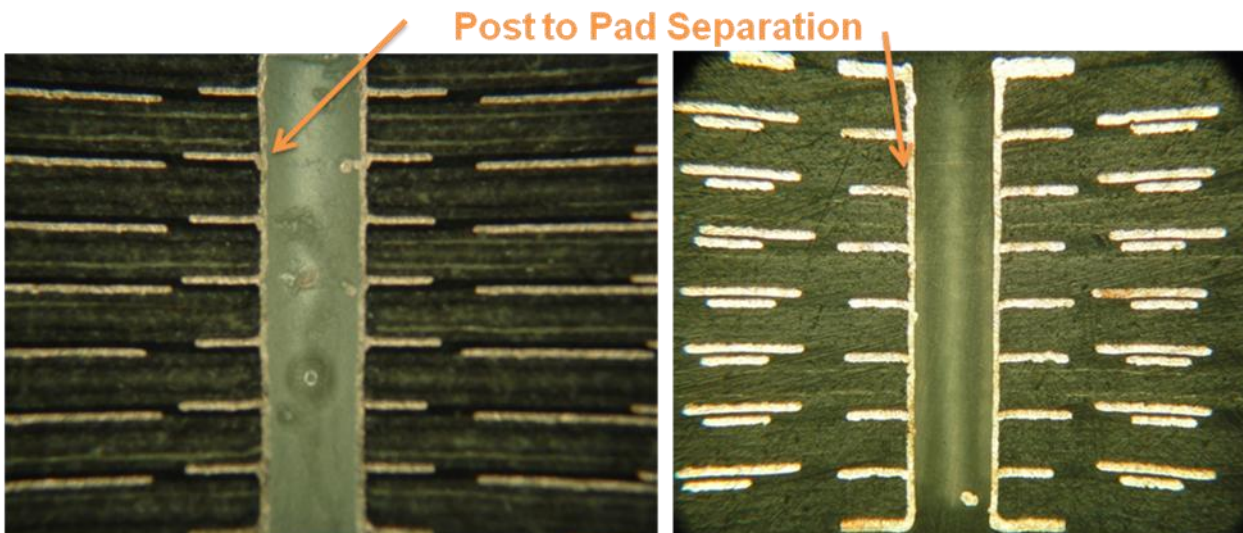
The TSM-DS/FEP stackup drilled in a fashion consistent with the other thermoplastic film (PCTFE: HT1.5 bond ply, Arlon6700, RO3001). There were some areas with no obvious pad to post separation and there were areas of severe pad to post separation. There were serious nodules on drilling entry and there were random nodules in the middle of the pth. Again, entry nodule problem is more likely related to the entry material used during drilling and a thick phenolic material with a combination of drill dwell between hits and the optimum bit geometry could probably fix this issues. Some amount of nodules on entry was found across all the prepregs so this is more likely related to the drill setup rather than a particular prepreg. Like the other thermoplastic film PCTFE (HT1.5bond ply, Arlon6700, RO3001), it was easy to find defects.

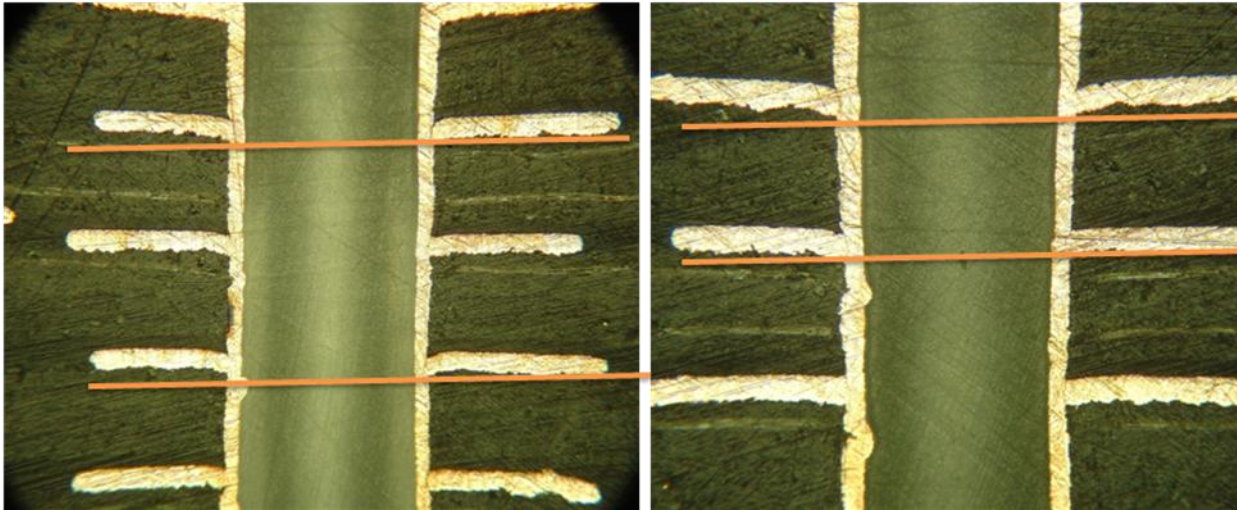
Post to pad interconnect looked inconsistent across all cross sections observed. Like the PCTFE bonding film, the TSM-DS/FEP stackup seemed to suffer from a lack of planarity of the pads from layer to layer. It is postulated that as the drill bit heated the pwb, the FEP softened to the point where there was some deflection of the pads as the drill bit drilled into the pwb. This can be seen in the following pictures.

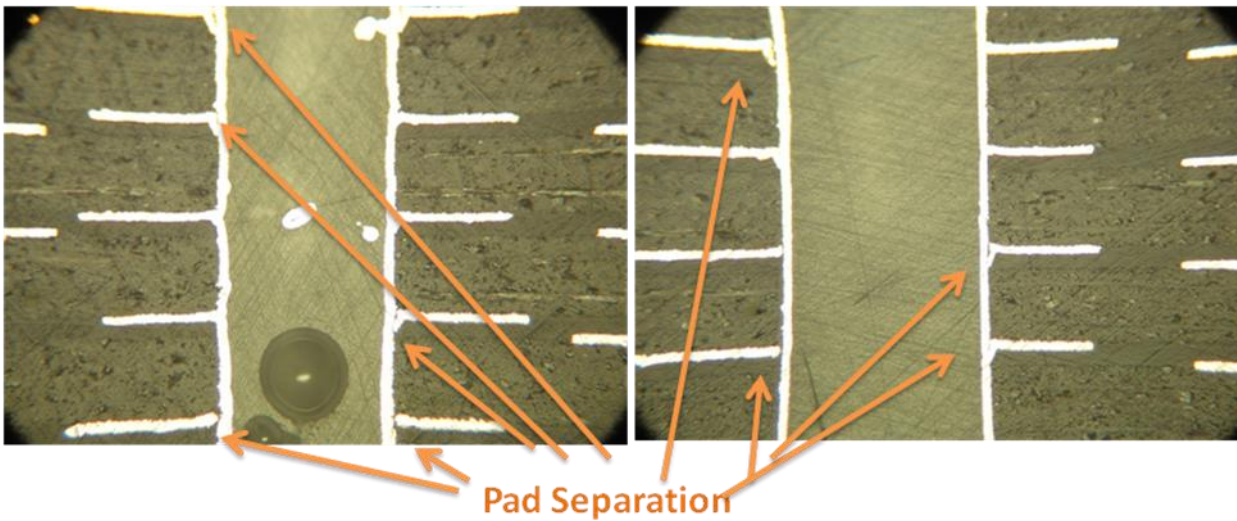
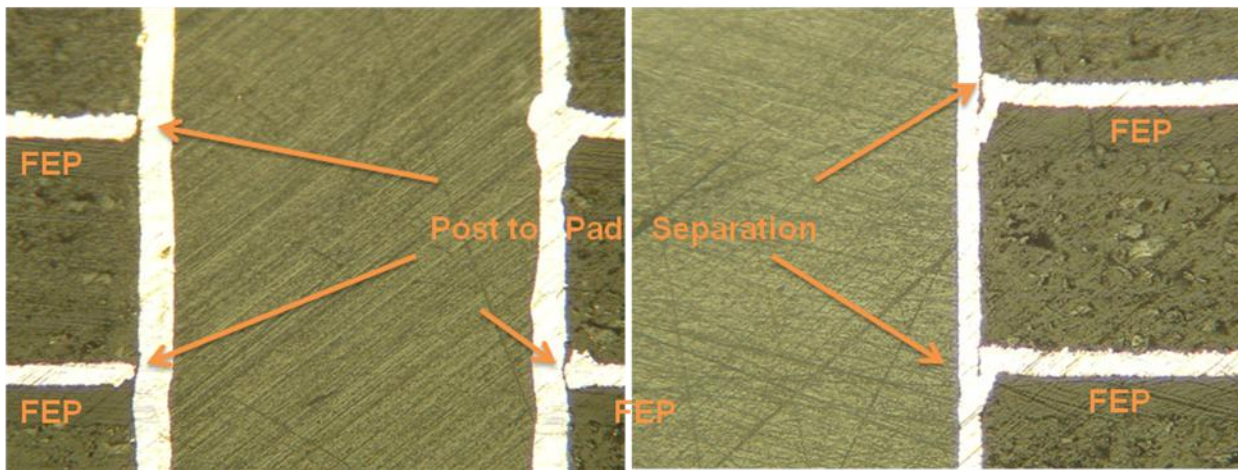
Pad to post separation varied from hole to hole. There were some clean holes and there were some plated through holes where half the pads or more had a pad to barrel interconnect defect.
